Problem:

When FL-7000 is in operate mode, after switching to RX , RX signal drops 10-15db and more.

Change the RL 13:

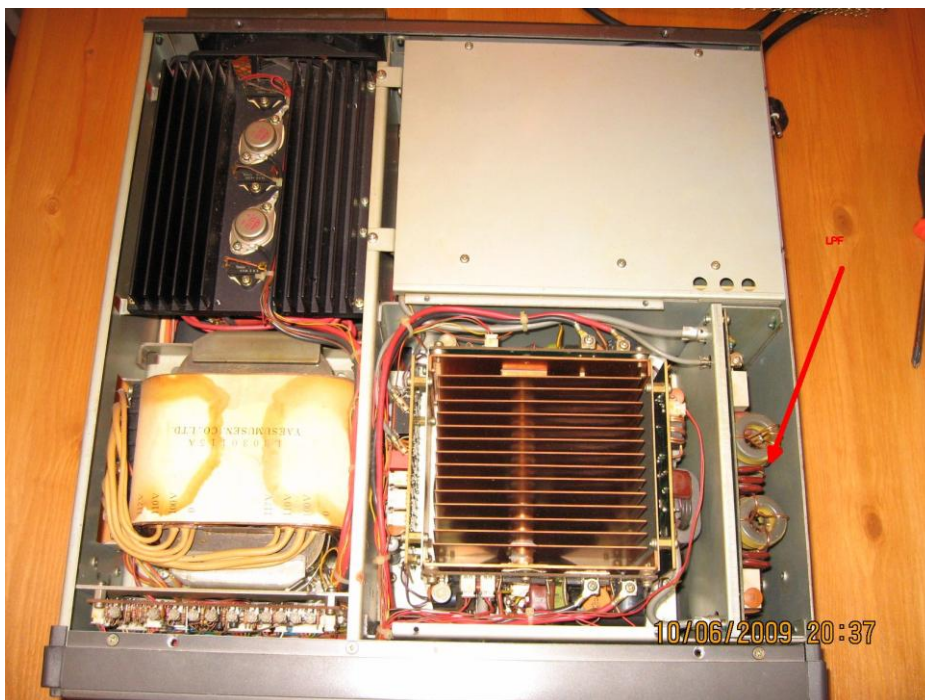
Locate the LPF board after opening FL-7000

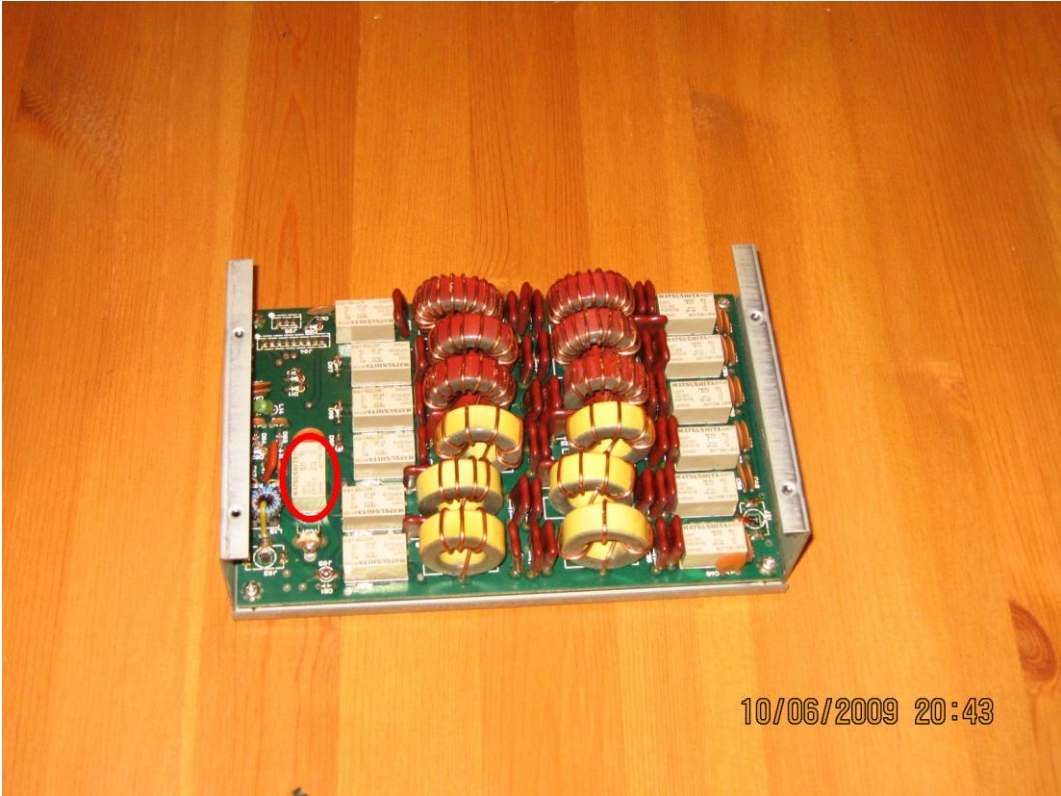
The schematics show RL13 at the LPF board, which switches RX/TX in operate mode.

Locate RL13
